# ALERT SERVICE BULLETIN

ENGINE — BLADE ASSEMBLY, 1ST STAGE, LOW PRESSURE COMPRESSOR (LPC)  
— ULTRASONIC TESTING (UT) INSPECTION AND THERMAL ACOUSTIC IMAGE (TAI)  
INSPECTION OF 1ST STAGE LPC BLADE ASSEMBLIES TO FIND AIRFOIL CRACKS

PW4G-112 Series A72-361

**PW4G-112-A72-361**

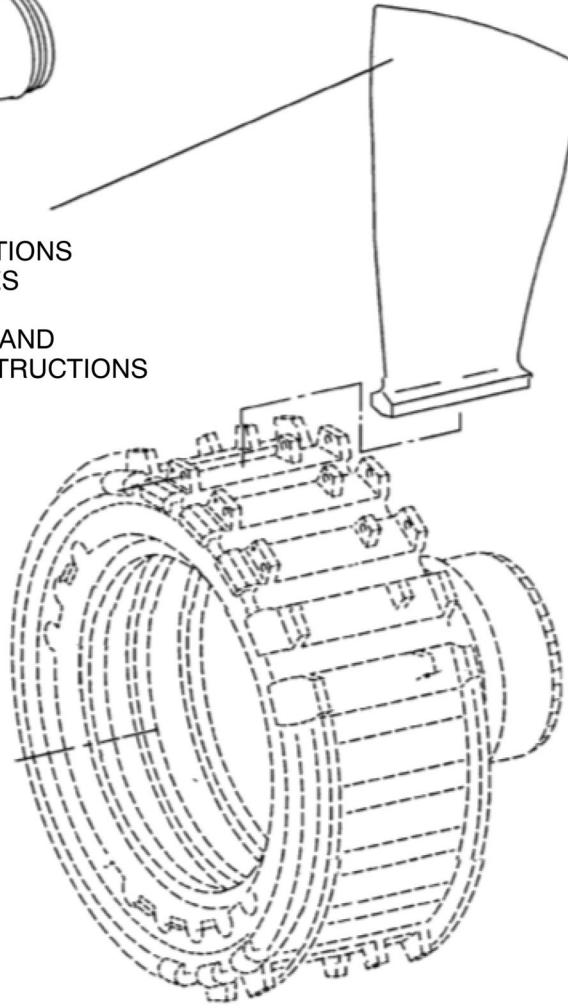
LOCATION OF THE LPC FAN BLADES  
72-31-00  
FIGURE 1

DO UT AND TAI INSPECTIONS  
OF THE LPC FAN BLADES  
AS SPECIFIED IN THE  
COMPLIANCE SECTION AND  
ACCOMPLISHMENT INSTRUCTIONS  
(22 LOCATIONS)
